NDI ID PA 00640

## LAKE AKIBA DAM

### PHASE I INSPECTION REPORT NATIONAL DAM INSPECTION PROGRAM

Name of Dam:	Lake Akiba Dam
State:	Pennsylvania
County:	Monroe
Stream:	Sandspring Creek
Coordinates:	N40°59.3', W75°21.3'
Dates of Inspections:	May 20, 1981 & June 1, 1981

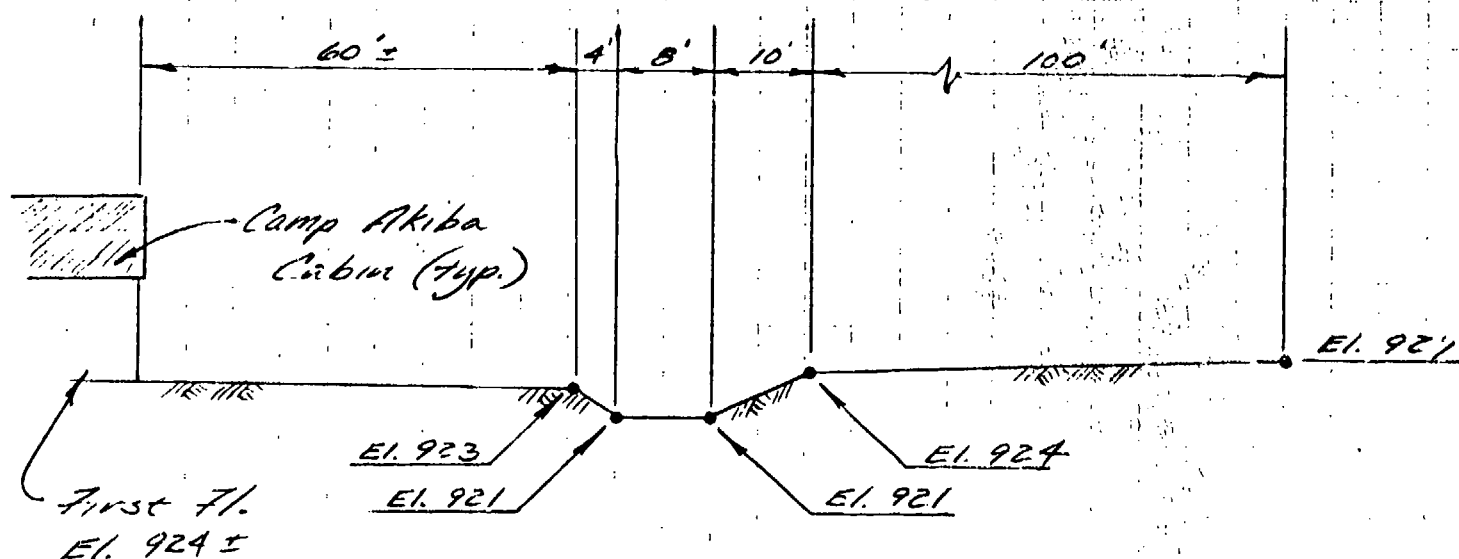
Hazard Area - DS-1 (looking d/s)  
(approximately 100 feet d/s)

The existing spillway capacity is not adequate to pass the flow anticipated during a  $\frac{1}{2}$ -PMF event. Therefore, a breach analysis of the dam was performed to determine the extent of flooding in the primary hazard areas. The breach was assumed to occur when the water surface reached el. 947, or at the point where the dam was overtopped by one foot. This hypothetical breach was assumed to develop gradually over a one hour period, with a base width of 140 feet and side slopes of 2H:1V.

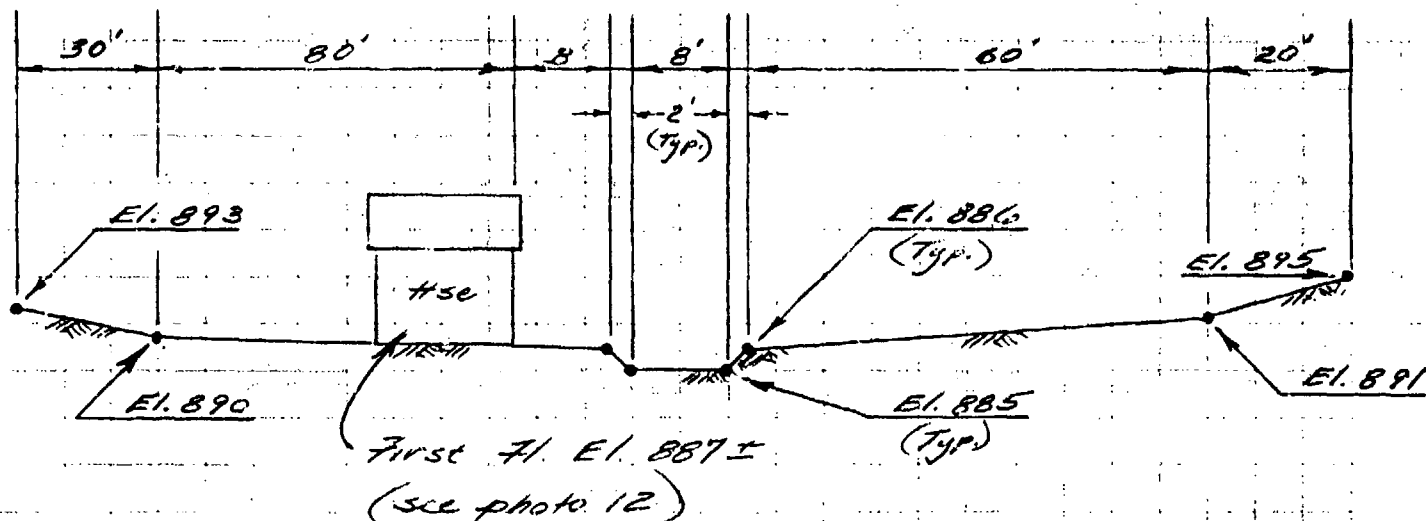
Hazard Area - DS-2 (looking d/s)

(approximately 1 mile d/s of dam)
